LEBANON RESERVOIR DAM No. 1

Number  
NDI ID. PA-00595,  
PENNDER ID. No. 38-1.

Susquehanna River Basin, West Branch of  
Hammer Creek, Lebanon County, Pennsylvania.  
PHASE I INSPECTION REPORT,  
NATIONAL DAM INSPECTION PROGRAM

GAI CONSULTANTS, INC.  
570 BEATTY ROAD  
MONROEVILLE, PENNSYLVANIA 15146

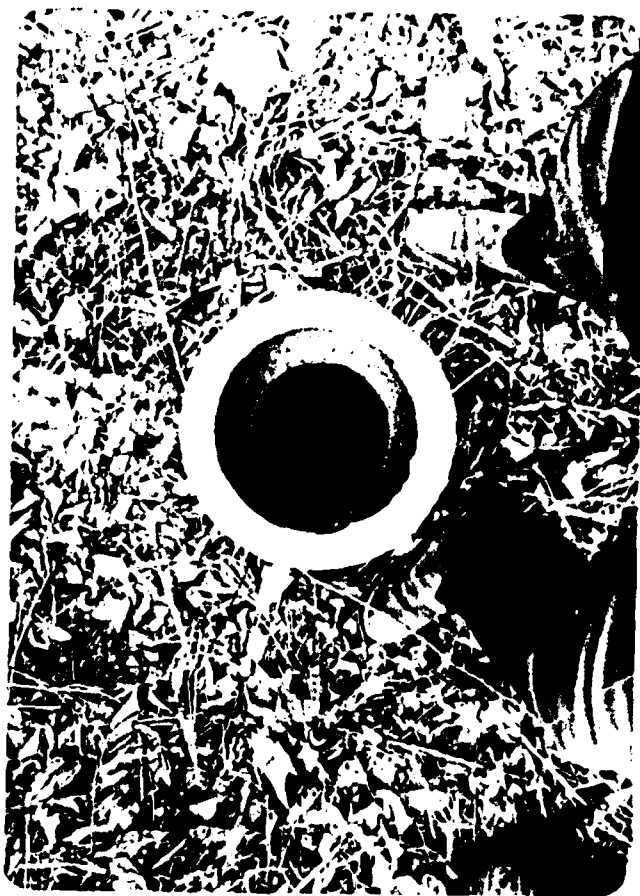
through the conduit is controlled by a valve located about midway along the downstream slope and to the right (looking downstream) of the chamber. Operation of the upstream valve is provided through a curb box opening (see Photograph 8). Some minor seepage ( $\approx$  2 gpm) was observed around the conduit at the base of the chamber.

PHOTOGRAPH 8 View of the curb box accessing the stem of an outlet conduit valve near the middle of the downstream slope to the right (looking downstream) of the valve chamber.

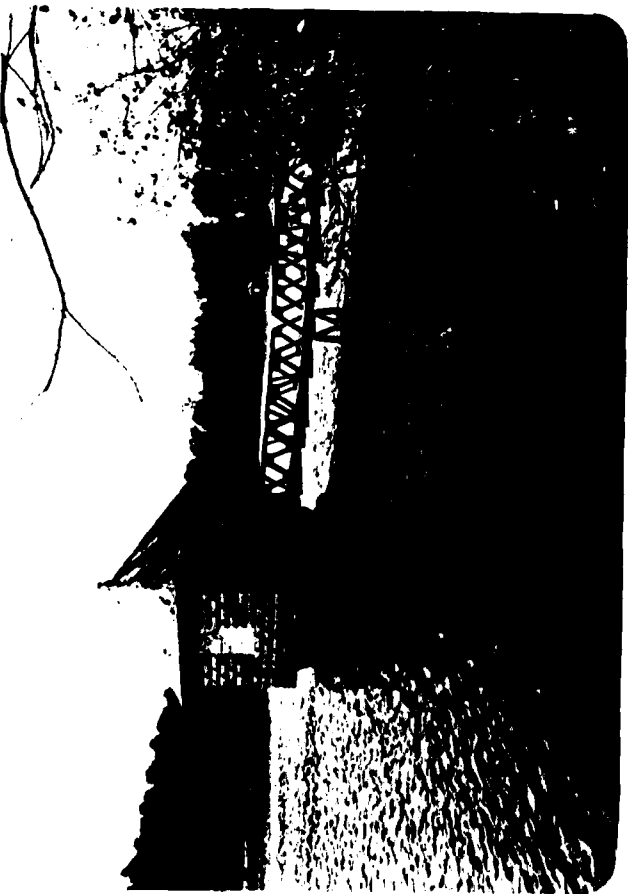
PHOTOGRAPH 5 View of the boarded-up masonry gate house located along the upstream embankment slope.
